# BRINKLEY

## CSC-2302 Interior Soffit Repair

**Notification Date 2-8-23**

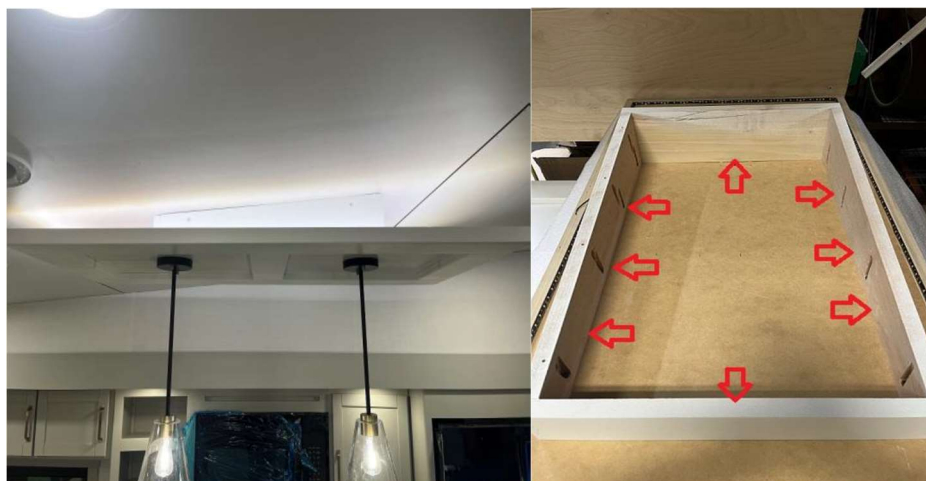
BRV has issued a Customer Satisfaction Campaign (CSC-2302) regarding the island soffit panel. The affected units in the vin range could have a loose securement allowing the panel to sag.

Drop the island lighting panel and box to gain access to the framing above (Pics attached). At that point locate the rafter area within the framing and add additional 2 ½” fasteners to the framing where applicable.

Separate the lighting panel from the soffit box and add a 1/8” bead of Sikaflex or Trem Pro Chem X adhesive between the panel and soffit then reattach. Clearing any oozing before resecuring to the ceiling.
