BRINKLEY

Attic Vent Replacement

CSC-2304

Notification Date 2-8-23

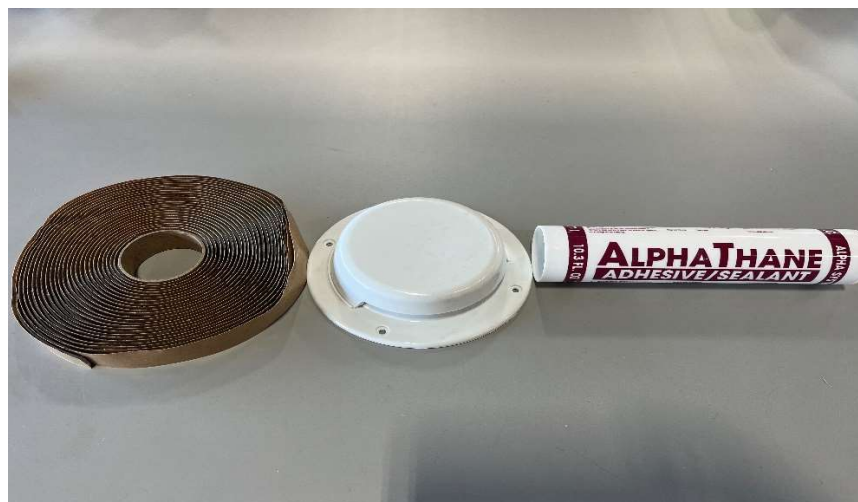
BRV has issued a Customer Satisfaction Campaign (CSC-2304) regarding the Attic vents on the roof assembly. The affected units in this vin range had a primer applied to the attic vent itself that could cause the material to prematurely crack allowing water infiltration into the roofing assembly.

Remove and Replace ALL attic vents on roofing assembly with BRV supplied parts and sealants.
